**Flood Control Project Maintenance
Levee Inspections**

Fall 2014 Levee Maintenance Deficiency Summary Report

San Joaquin River Basin

Reclamation District No. 0017 Mossdale

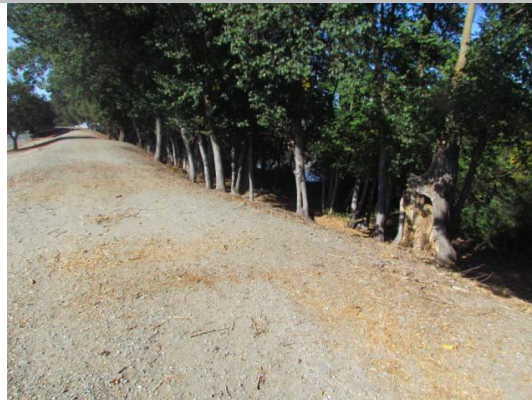
Photo 1 of 4 : FA_2014_RD0017_303_12_20141023_00004.jpg

LM Start	0.03	Rating **	A	Issue No.	12
LM End	0.03	Issue Type +	Ma	Location *	WS
Category	Earthen Levee			GPS Latitude/Longitude	
				Start	End
Item	Encroachments			37.911629 °	37.911629 °
				-121.291585 °	-121.291585 °
DWR ID	DWR_RD0017_01_s_2014_12				
Action/Comments					
Tree or limb

Looking north at corrected site.

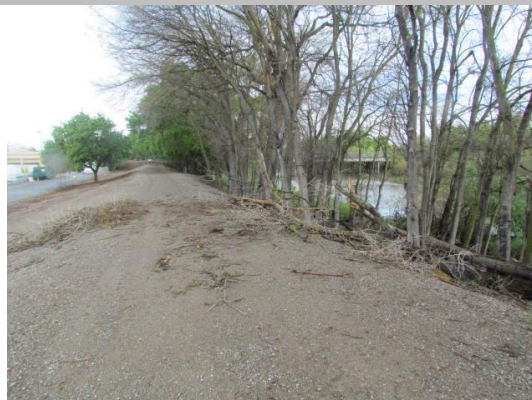
Photo 2 of 4 : FA_2014_RD0017_303_12_20141010_00001.jpg

LM Start	0.03	Rating **	A	Issue No.	12 (cont)
LM End	0.03	Issue Type +	Ma	Location *	WS

Looking north at tree limbs across levee crown and slope.

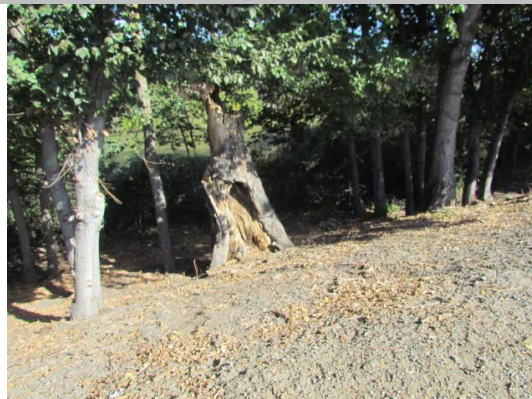
Photo 3 of 4 : FA_2014_RD0017_303_12_20141023_00003.jpg

LM Start	0.03	Rating **	A	Issue No.	12 (cont)	
LM End	0.03	Issue Type +	Ma	Location *	WS	
Category	Earthen Levee			GPS Latitude/Longitude		
				Start		End
Item	Encroachments			37.911629 °		37.911629 °
				-121.291585 °		-121.291585 °
DWR ID	DWR_RD0017_01_s_2014_12					
Action/Comments						
Tree or limb

Looking east at corrected site.

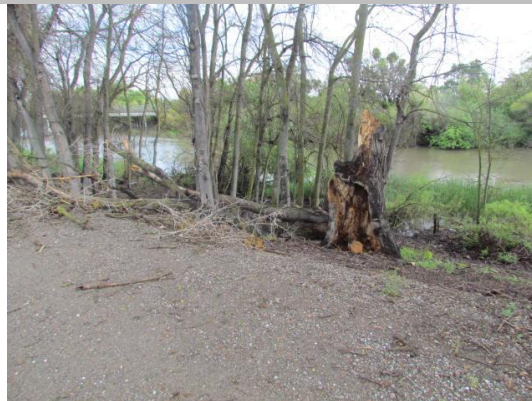
Photo 4 of 4 : FA_2014_RD0017_303_12_20141010_00002.jpg

LM Start	0.03	Rating **	A	Issue No.	12 (cont)
LM End	0.03	Issue Type +	Ma	Location *	WS

Looking northeast at down tree on waterward slope.

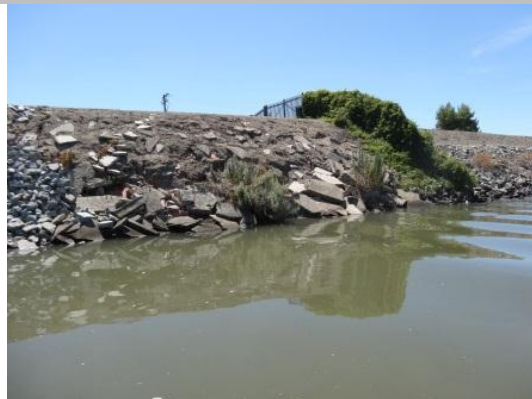
Photo 1 of 1 : SJR2014_RD0017U02RM44.32_1.jpg

LM Start	1.08	Rating **	U	Issue No.	6
LM End	1.08	Issue Type +	Ma	Location *	WS
Category	Supplemental			GPS Latitude/Longitude	
				Start	End
Item	DWR Erosion Survey			37.902530 °	37.902530 °
				-121.325690 °	-121.325690 °
DWR ID					
Action/Comments					
Inspector Comments: 6/19/2014: No significant change observed. 08/13/2013: No significant change at this site. 08/07/2012: The erosion is nearly vertical, and has developed upward to halfway of the levee slope. The protecting concrete blocks have been washed away. Animal activities are visible. [2014 Site ID:RD0017U02RM44.32]

Front view of the erosion site. Note the concrete blocks and vegetation.

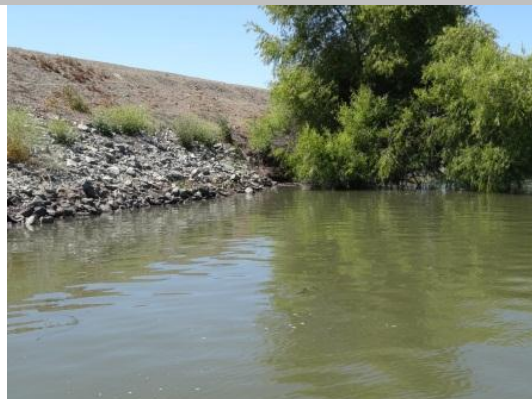
Photo 1 of 1 : SJR2014_RD0017U02RM44.52_1.jpg

LM Start	1.28	Rating **	M	Issue No.	14
LM End	1.28	Issue Type +	Ma	Location *	WS
Category	Supplemental			GPS Latitude/Longitude	
				Start	End
Item	DWR Erosion Survey			37.899510 °	37.899510 °
				-121.326030 °	-121.326030 °
DWR ID					
Action/Comments					
Inspector Comments: 06/19/2014: The erosion has been repaired. A minor erosion is still visible near the tree.					
08/13/2013: A mid-size tree is present immediately upstream of the erosion, which could block the view of the site. Some debris is visible.					
[2014 Site ID:RD0017U02RM44.52]

View from downstream.

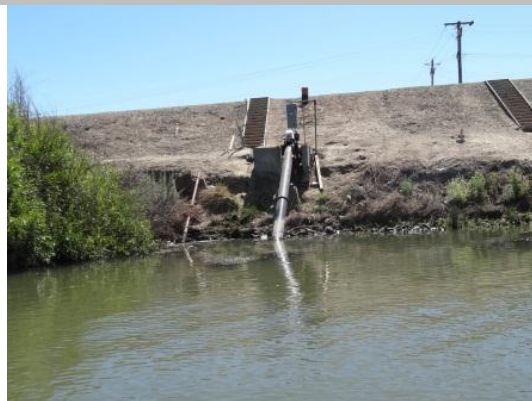
Photo 1 of 1 : SJR2014_RD0017U02RM45.94_1.jpg

LM Start	2.66	Rating **	M	Issue No.	92
LM End	2.66	Issue Type +	Ma	Location *	WS
Category	Supplemental			GPS Latitude/Longitude	
				Start	End
Item	DWR Erosion Survey			37.881020 °	37.881020 °
				-121.332260 °	-121.332260 °
DWR ID					
Action/Comments					
Inspector Comments: 6/19/2014: The erosion was probably caused by the irrigation pipe found at the site. [2014 Site ID:RD0017U02RM45.94]

Close view of the erosion site.

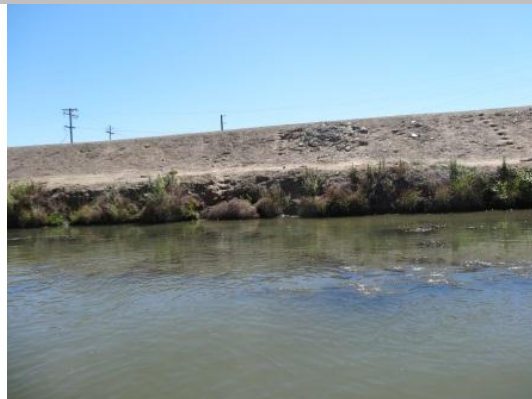
Photo 1 of 1 : SJR2014_RD0017U02RM45.95_1.jpg

LM Start	2.71	Rating **	M	Issue No.	93
LM End	2.73	Issue Type +	Ma	Location *	WS
Category	Supplemental			GPS Latitude/Longitude	
				Start	End
Item	DWR Erosion Survey			37.880710 °	37.880710 °
				-121.332200 °	-121.332200 °
DWR ID					
Action/Comments					
Inspector Comments: 6/19/2014: The erosion is in the river bank which has an estimated 10-ft wide berm. [2014 Site ID:RD0017U02RM45.95]

Front view of the erosion along the water edge. Note the vegetation at the erosion site.

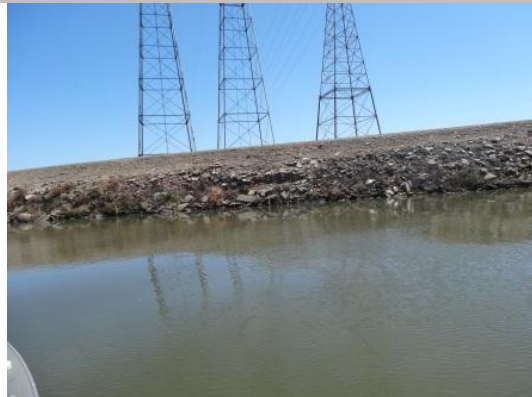
Photo 1 of 1 : SJR2014_RD0017U02RM46.1_1.jpg

LM Start	2.81	Rating **	M	Issue No.	95
LM End	2.81	Issue Type +	Ma	Location *	WS
Category	Supplemental			GPS Latitude/Longitude	
				Start	End
Item	DWR Erosion Survey			37.878660 °	37.878660 °
				-121.332400 °	-121.332400 °
DWR ID					
Action/Comments					
Inspector Comments: 06/19/2014: A pocket erosion was found during the boat survey. [2014 Site ID:RD0017U02RM46.1]

Front view of the erosion.

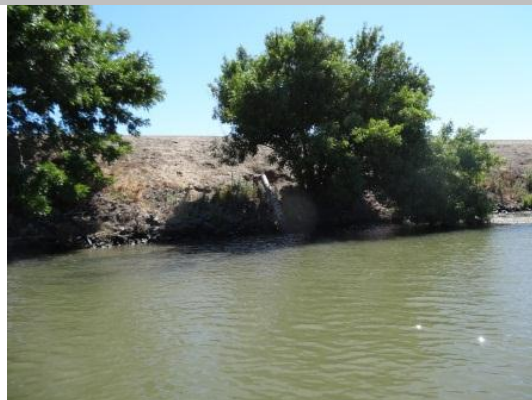
Photo 1 of 1 : SJR2014_RD0017U02RM46.89_1.jpg

LM Start	3.62	Rating **	M	Issue No.	96
LM End	3.62	Issue Type +	Ma	Location *	WS
Category	Supplemental			GPS Latitude/Longitude	
				Start	End
Item	DWR Erosion Survey			37.868500 °	37.868500 °
				-121.327670 °	-121.327670 °
DWR ID					
Action/Comments					
Inspector Comments: 06/19/2014: The erosion is near a large tree and probably has been caused by the irrigation pipe on the site. [2014 Site ID:RD0017U02RM46.89]

Front view of the erosion. Note the tree and the irrigation pipe.

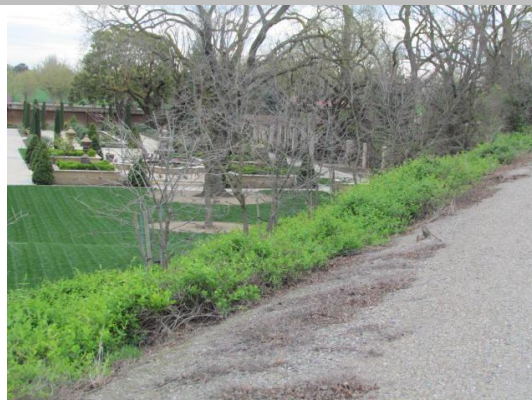
Photo 1 of 3 : FA_2014_RD0017_304_48_20141010_00017.jpg

LM Start	4.24	Rating **	M	Issue No.	48
LM End	4.27	Issue Type +	En	Location *	LS
Category	Earthen Levee			GPS Latitude/Longitude	
				Start	End
Item	Vegetation			37.863819 °	37.863601 °
				-121.320784 °	-121.320299 °
DWR ID	DWR_RD0017_02_s_2012_48				
Action/Comments					
Landscaping

Looking southeast at dense ground cover on landside slope. (Spring 2013)

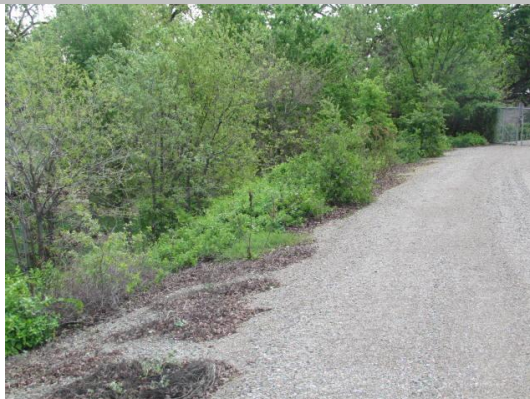
Photo 2 of 3 : FA_2014_RD0017_304_48_20141010_00018.jpg

LM Start	4.24	Rating **	M	Issue No.	48 (cont)	
LM End	4.27	Issue Type +	En	Location *	LS	
Category	Earthen Levee			GPS Latitude/Longitude		
				Start		End
Item	Vegetation			37.863819 °		37.863601 °
				-121.320784 °		-121.320299 °
DWR ID	DWR_RD0017_02_s_2012_48					
Action/Comments						
Landscaping

Looking southeast at overgrown landscaping on landside slope. (Spring 2014)

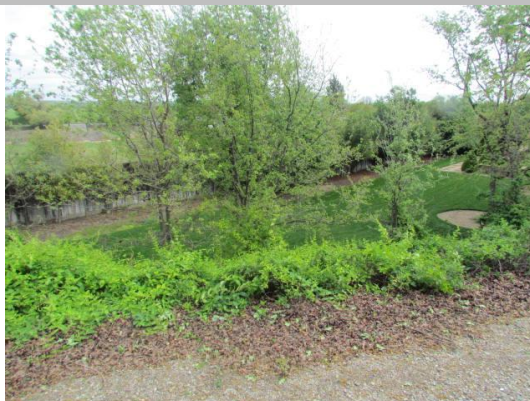
Photo 3 of 3 : FA_2014_RD0017_304_48_20141010_00019.jpg

LM Start	4.24	Rating **	M	Issue No.	48 (cont)
LM End	4.27	Issue Type +	En	Location *	LS

Looking east at overgrown landscaping on landside slope. (Spring 2014)

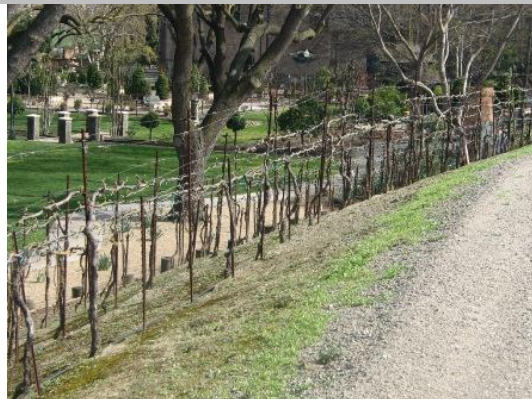
Photo 1 of 4 : FA_2014_RD0017_304_11_20141010_00006.jpg

LM Start	4.28	Rating **	U	Issue No.	11
LM End	4.32	Issue Type +	En	Location *	LS
Category	Earthen Levee			GPS Latitude/Longitude	
				Start	End
Item	Encroachments			37.863582 °	37.862947 °
				-121.320230 °	-121.319812 °
DWR ID	DWR_RD0017_02_s_2012_11				
Action/Comments					
Crops

Grape vines on landside slope from LM 4.28 to 4.32

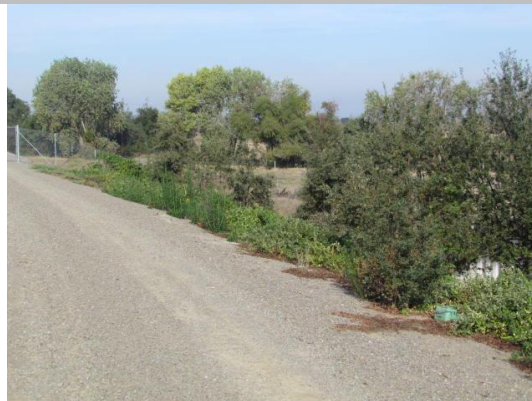
Photo 2 of 4 : FA_2014_RD0017_304_11_20141010_00007.jpg

LM Start	4.28	Rating **	U	Issue No.	11 (cont)
LM End	4.32	Issue Type +	En	Location *	LS

Looking northeast at dense landscaping on landside slope.

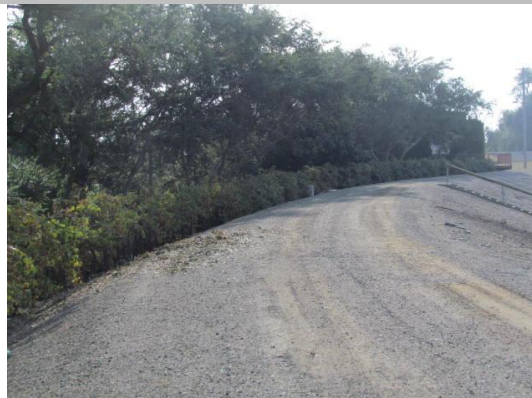
Photo 3 of 4 : FA_2014_RD0017_304_11_20141010_00008.jpg

LM Start	4.28	Rating **	U	Issue No.	11 (cont)
LM End	4.32	Issue Type +	En	Location *	LS

Looking south at landscaping with grape vines on landside slope

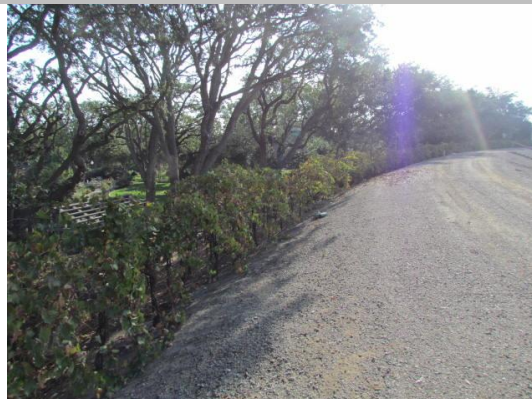
Photo 4 of 4 : FA_2014_RD0017_304_11_20141010_00009.jpg

LM Start	4.28	Rating **	U	Issue No.	11 (cont)
LM End	4.32	Issue Type +	En	Location *	LS
Category	Earthen Levee			GPS Latitude/Longitude	
				Start	End
Item	Encroachments			37.863582 °	37.862947 °
				-121.320230 °	-121.319812 °
DWR ID	DWR_RD0017_02_s_2012_11				
Action/Comments					
Crops

Looking southeast at grape vines on landside slope

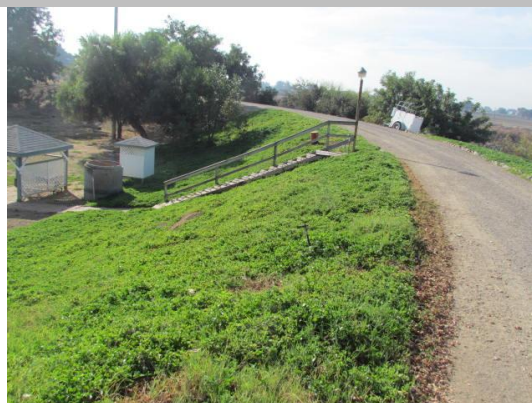
Photo 1 of 3 : FA_2014_RD0017_304_1_20141010_00001.jpg

LM Start	4.42	Rating **	U	Issue No.	1 (cont)
LM End	4.44	Issue Type +	En	Location *	LS

Looking southeast at ground cover on landside slope.

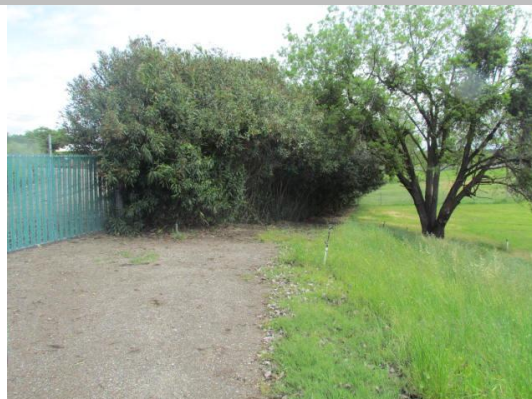
Photo 2 of 3 : FA_2014_RD0017_304_1_20141010_00002.jpg

Looking south at overgrown oleanders on landside shoulder. (Spring 2014)

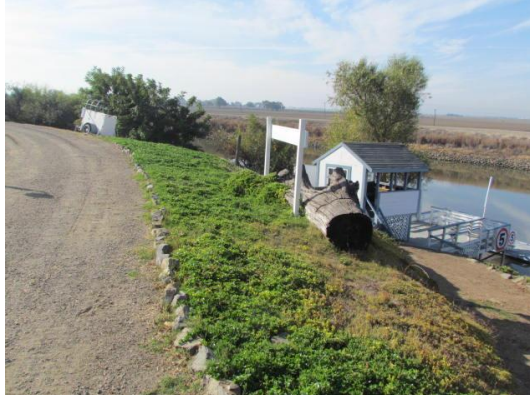
Photo 3 of 3 : FA_2014_RD0017_304_1_20141010_00003.jpg

LM Start	4.42	Rating **	U	Issue No.	1 (cont)	
LM End	4.44	Issue Type +	En	Location *	LS	
Category	Earthen Levee			GPS Latitude/Longitude		
				Start		End
Item	Vegetation			37.861673 °		37.861370 °
				-121.320115 °		-121.320102 °
DWR ID	DWR_RD0017_02_s_2012_1					
Action/Comments						
Landscaping

Looking southwest at landscaping and boat dock on waterside slope and channel.

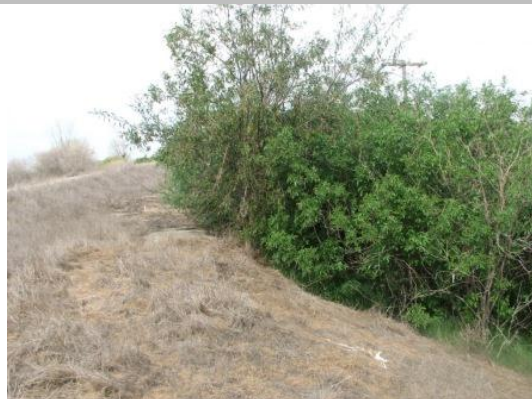
Photo 1 of 1 : FA_2014_RD0017_304_25_20141010_00016.jpg

LM Start	7.67	Rating **	M	Issue No.	25
LM End	7.69	Issue Type +	Ma	Location *	LS
Category	Earthen Levee			GPS Latitude/Longitude	
				Start	End
Item	Vegetation			37.828095 °	37.827920 °
				-121.309945 °	-121.309847 °
DWR ID	DWR_RD0017_02_s_2012_25				
Action/Comments					
Elderberries are blocking visibility and flood fight capability.

Elderberry blocking view of landside slope and toe from LM 7.67 to 7.69

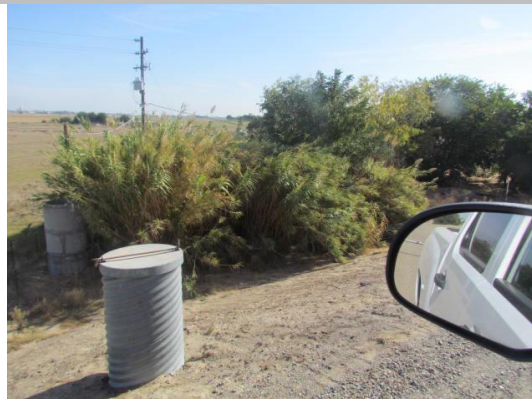
Photo 1 of 1 : FA_2014_RD0017_304_9_20141023_00028.jpg

LM Start	9.40	Rating **	M	Issue No.	9
LM End	9.40	Issue Type +	Ma	Location *	LS
Category	Earthen Levee			GPS Latitude/Longitude	
				Start	End
Item	Vegetation			37.815243 °	37.815243 °
				-121.317470 °	-121.317470 °
DWR ID	DWR_RD0017_02_s_2012_9				
Action/Comments					
Elderberries are blocking visibility and flood fight capability.

Looking east at bamboo at landward toe.
